Fires, flood risk, and water quality

Larimer County Water Education Series

August 21, 2023

Esther Vincent, P.E.

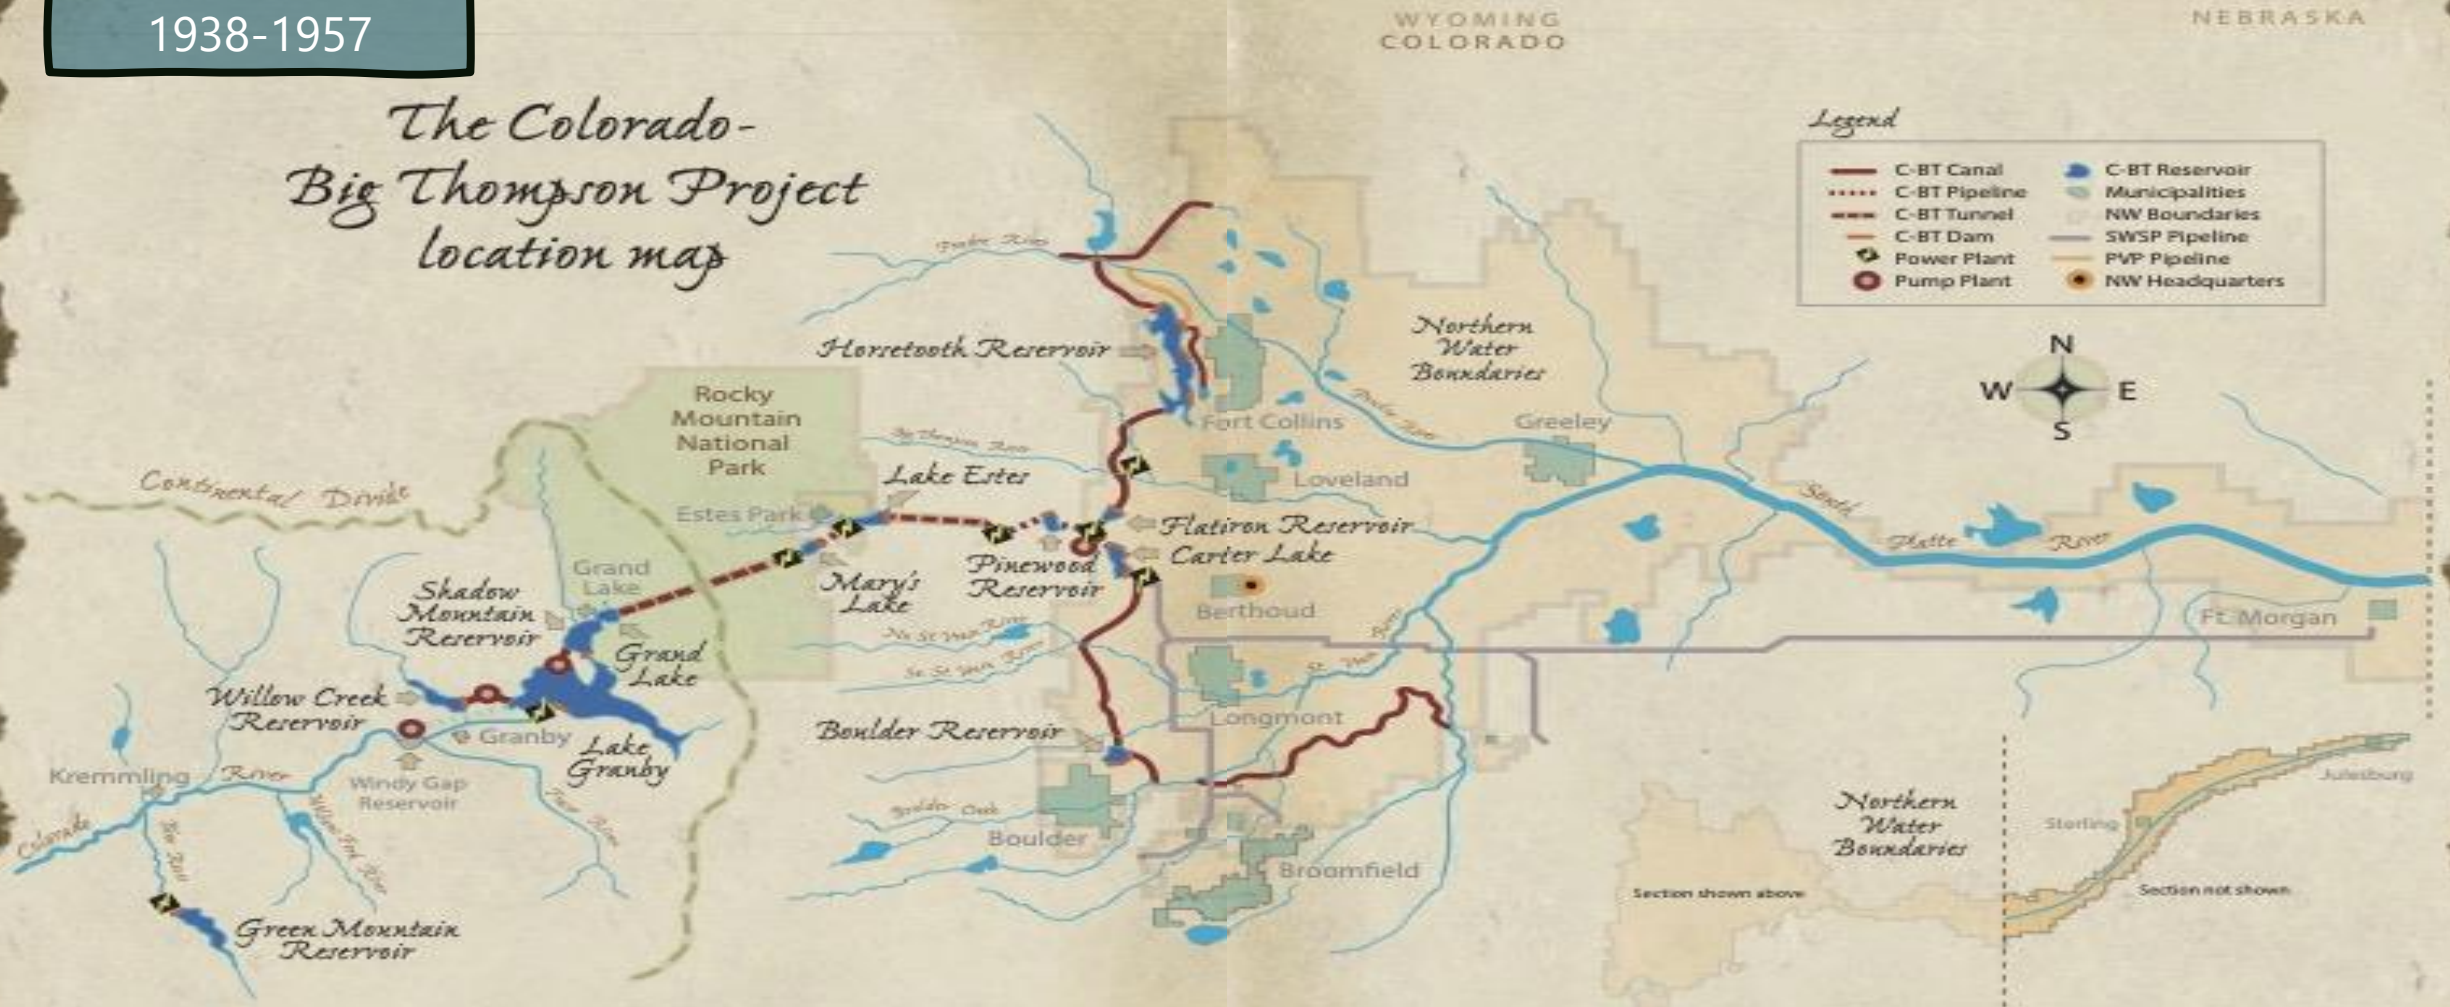
The Colorado- Big Thompson Project location map

CONSTRUCTED

1938-1957

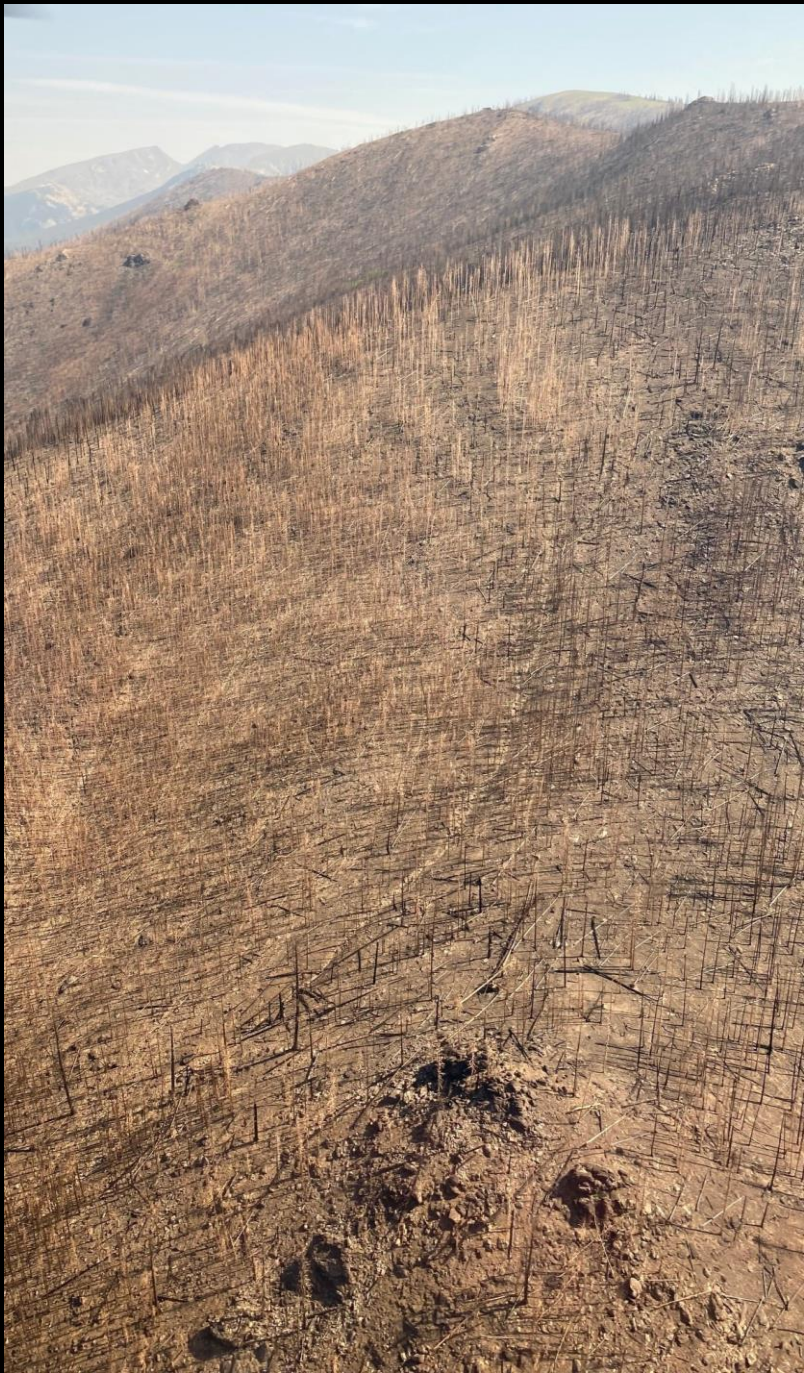
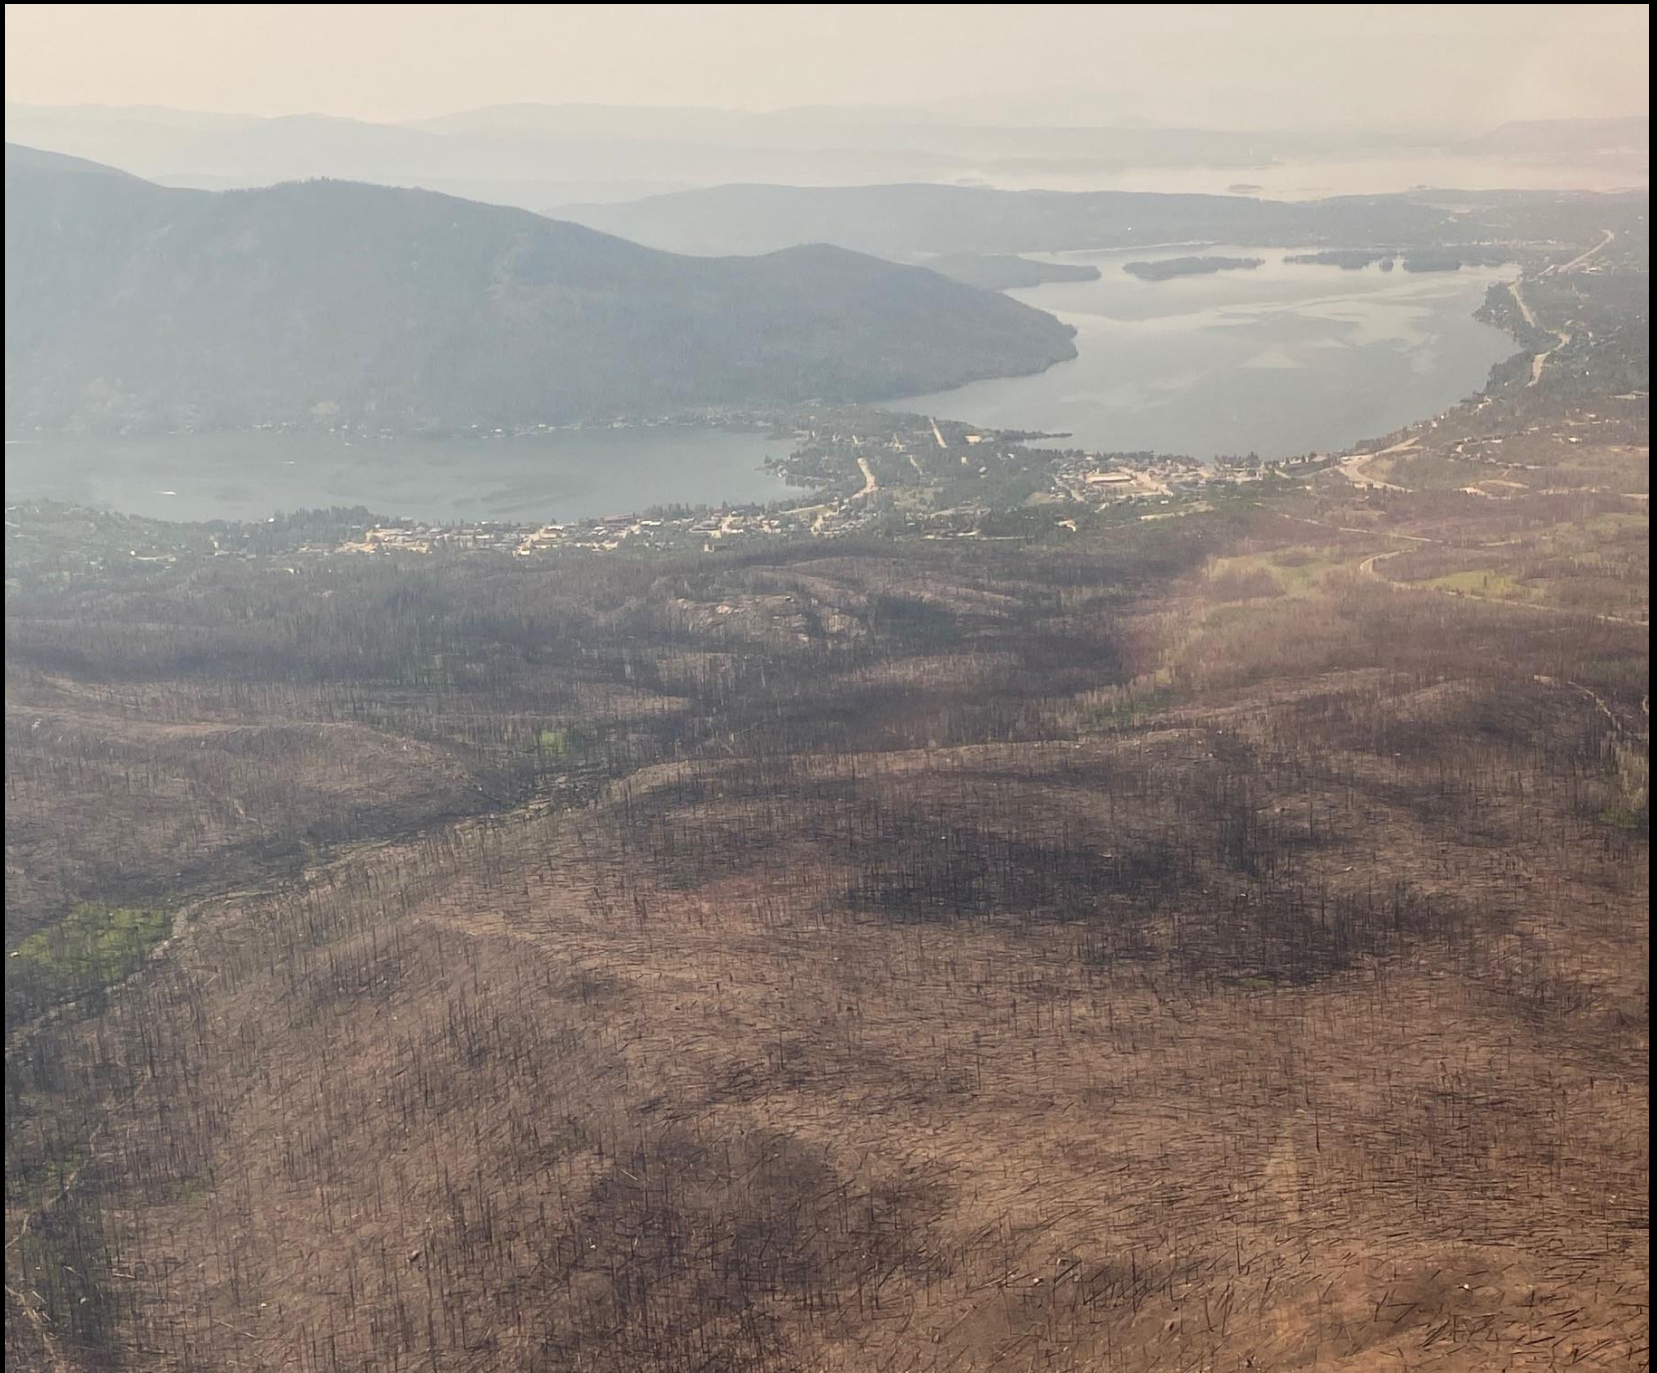
193,559 ac Burned

PRIVATE LAND
19,757 ac (10%)

FEDERAL LAND
168,908 ac (90%)

Soil Burn Severity

- High
- Moderate
- Low
- Unburned/Very Low
- Burn Area

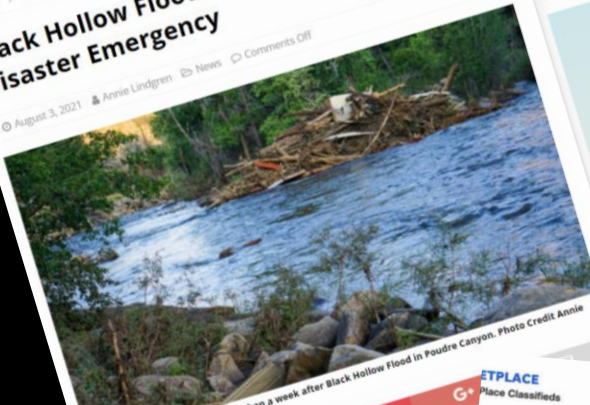
Photo taken on July 26, 2021, less than a week after Black Hollow Flood in Poudre Canyon. Photo Credit Annie Lindgren

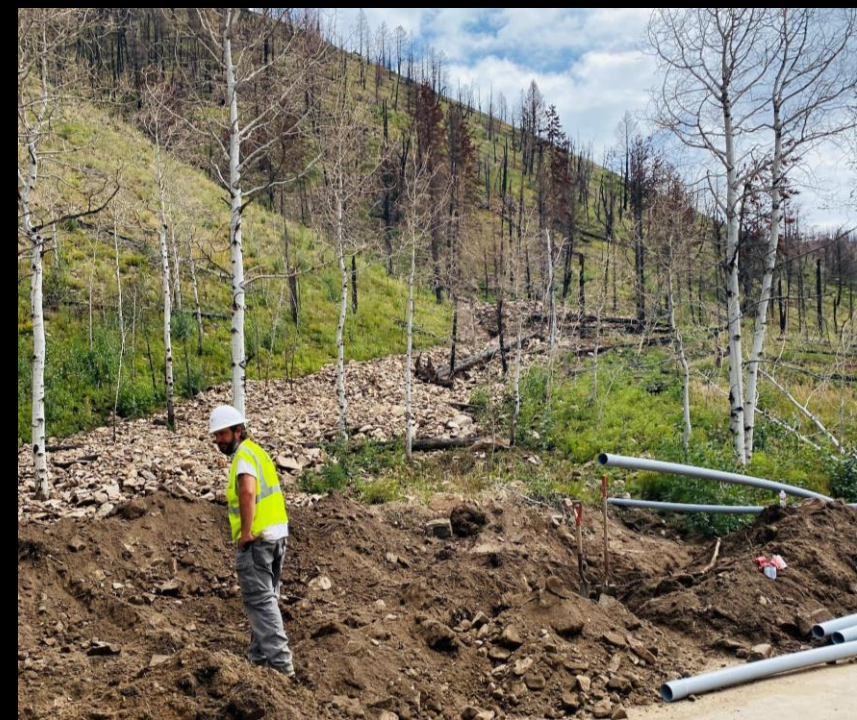
Highway 125 Grand County
(Willow Creek watershed)

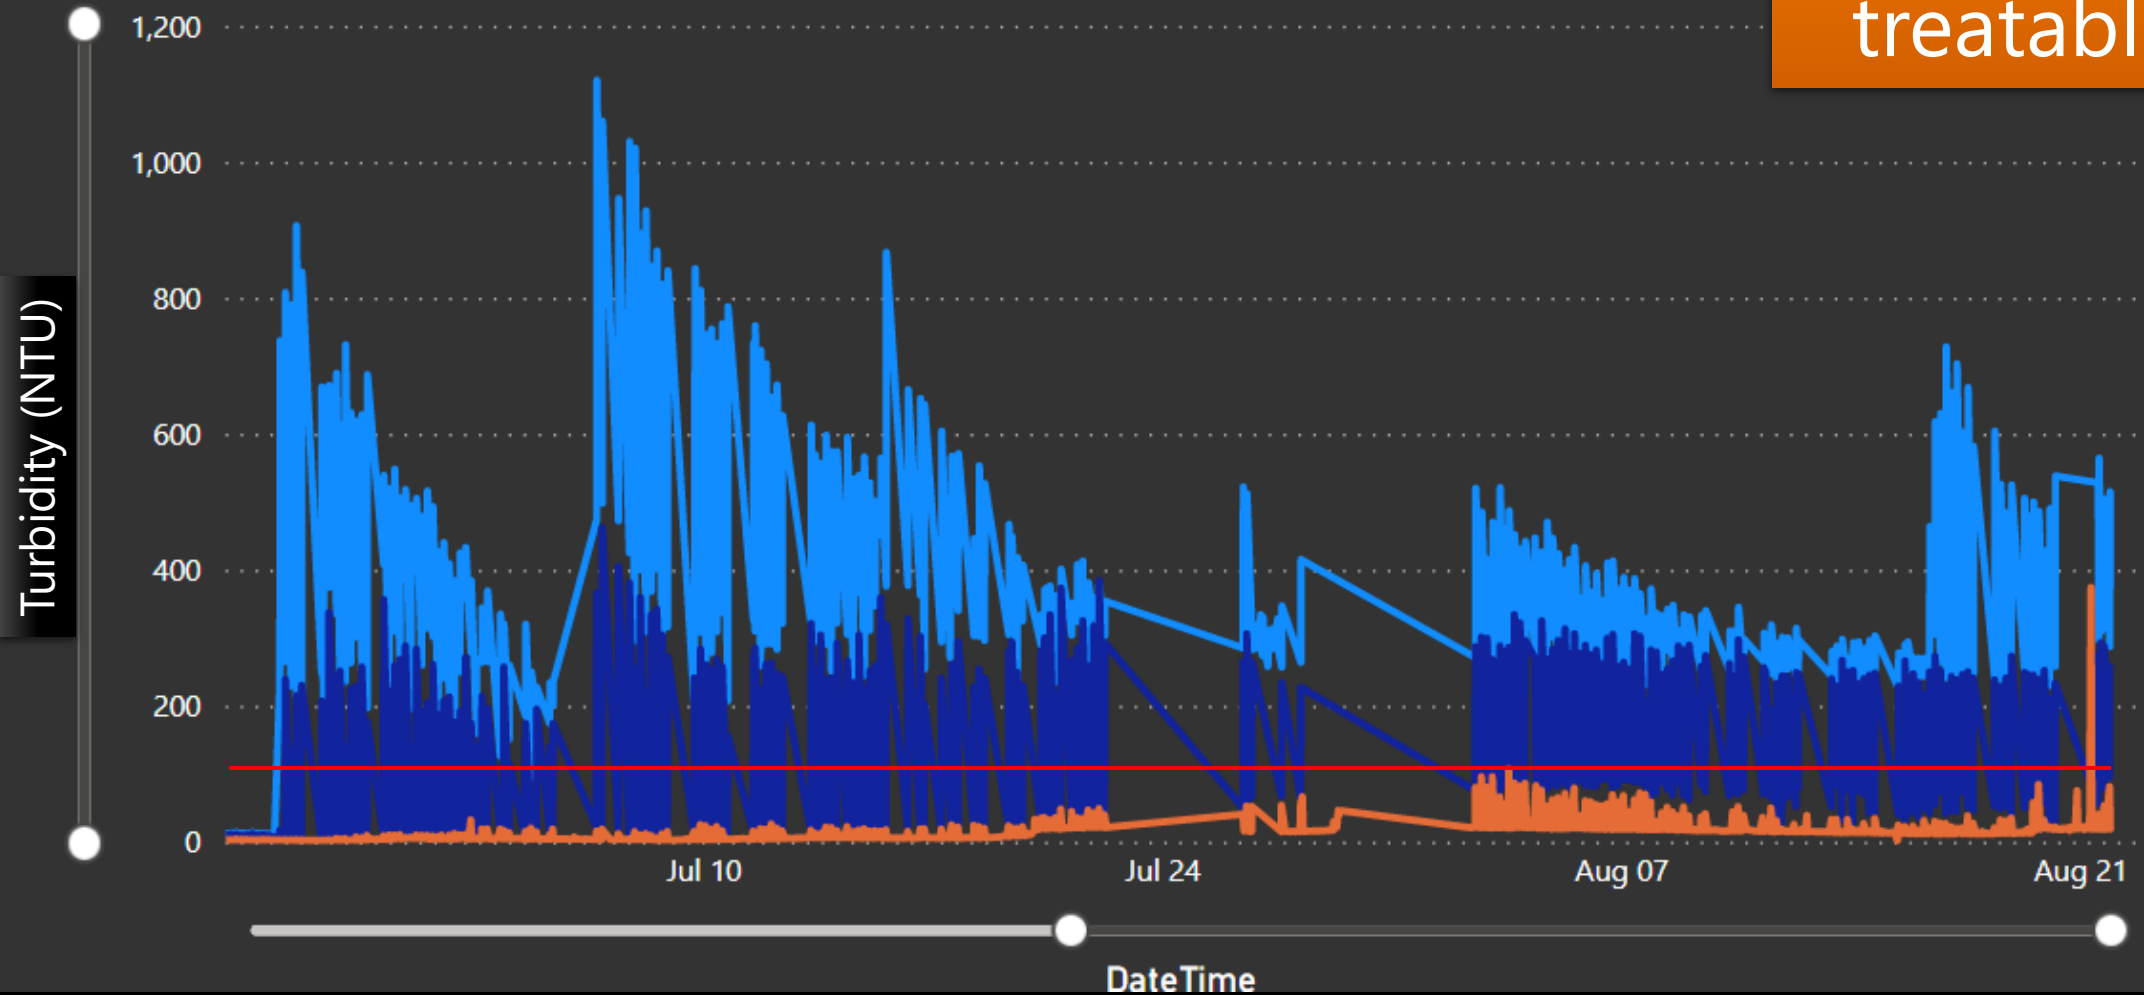
Willow Creek Reservoir Turbidity (NTU)

> 100 not treatable

Depth Classification ● Bottom (15-22m) ● Middle (5-15m) ● Top (0-5m)

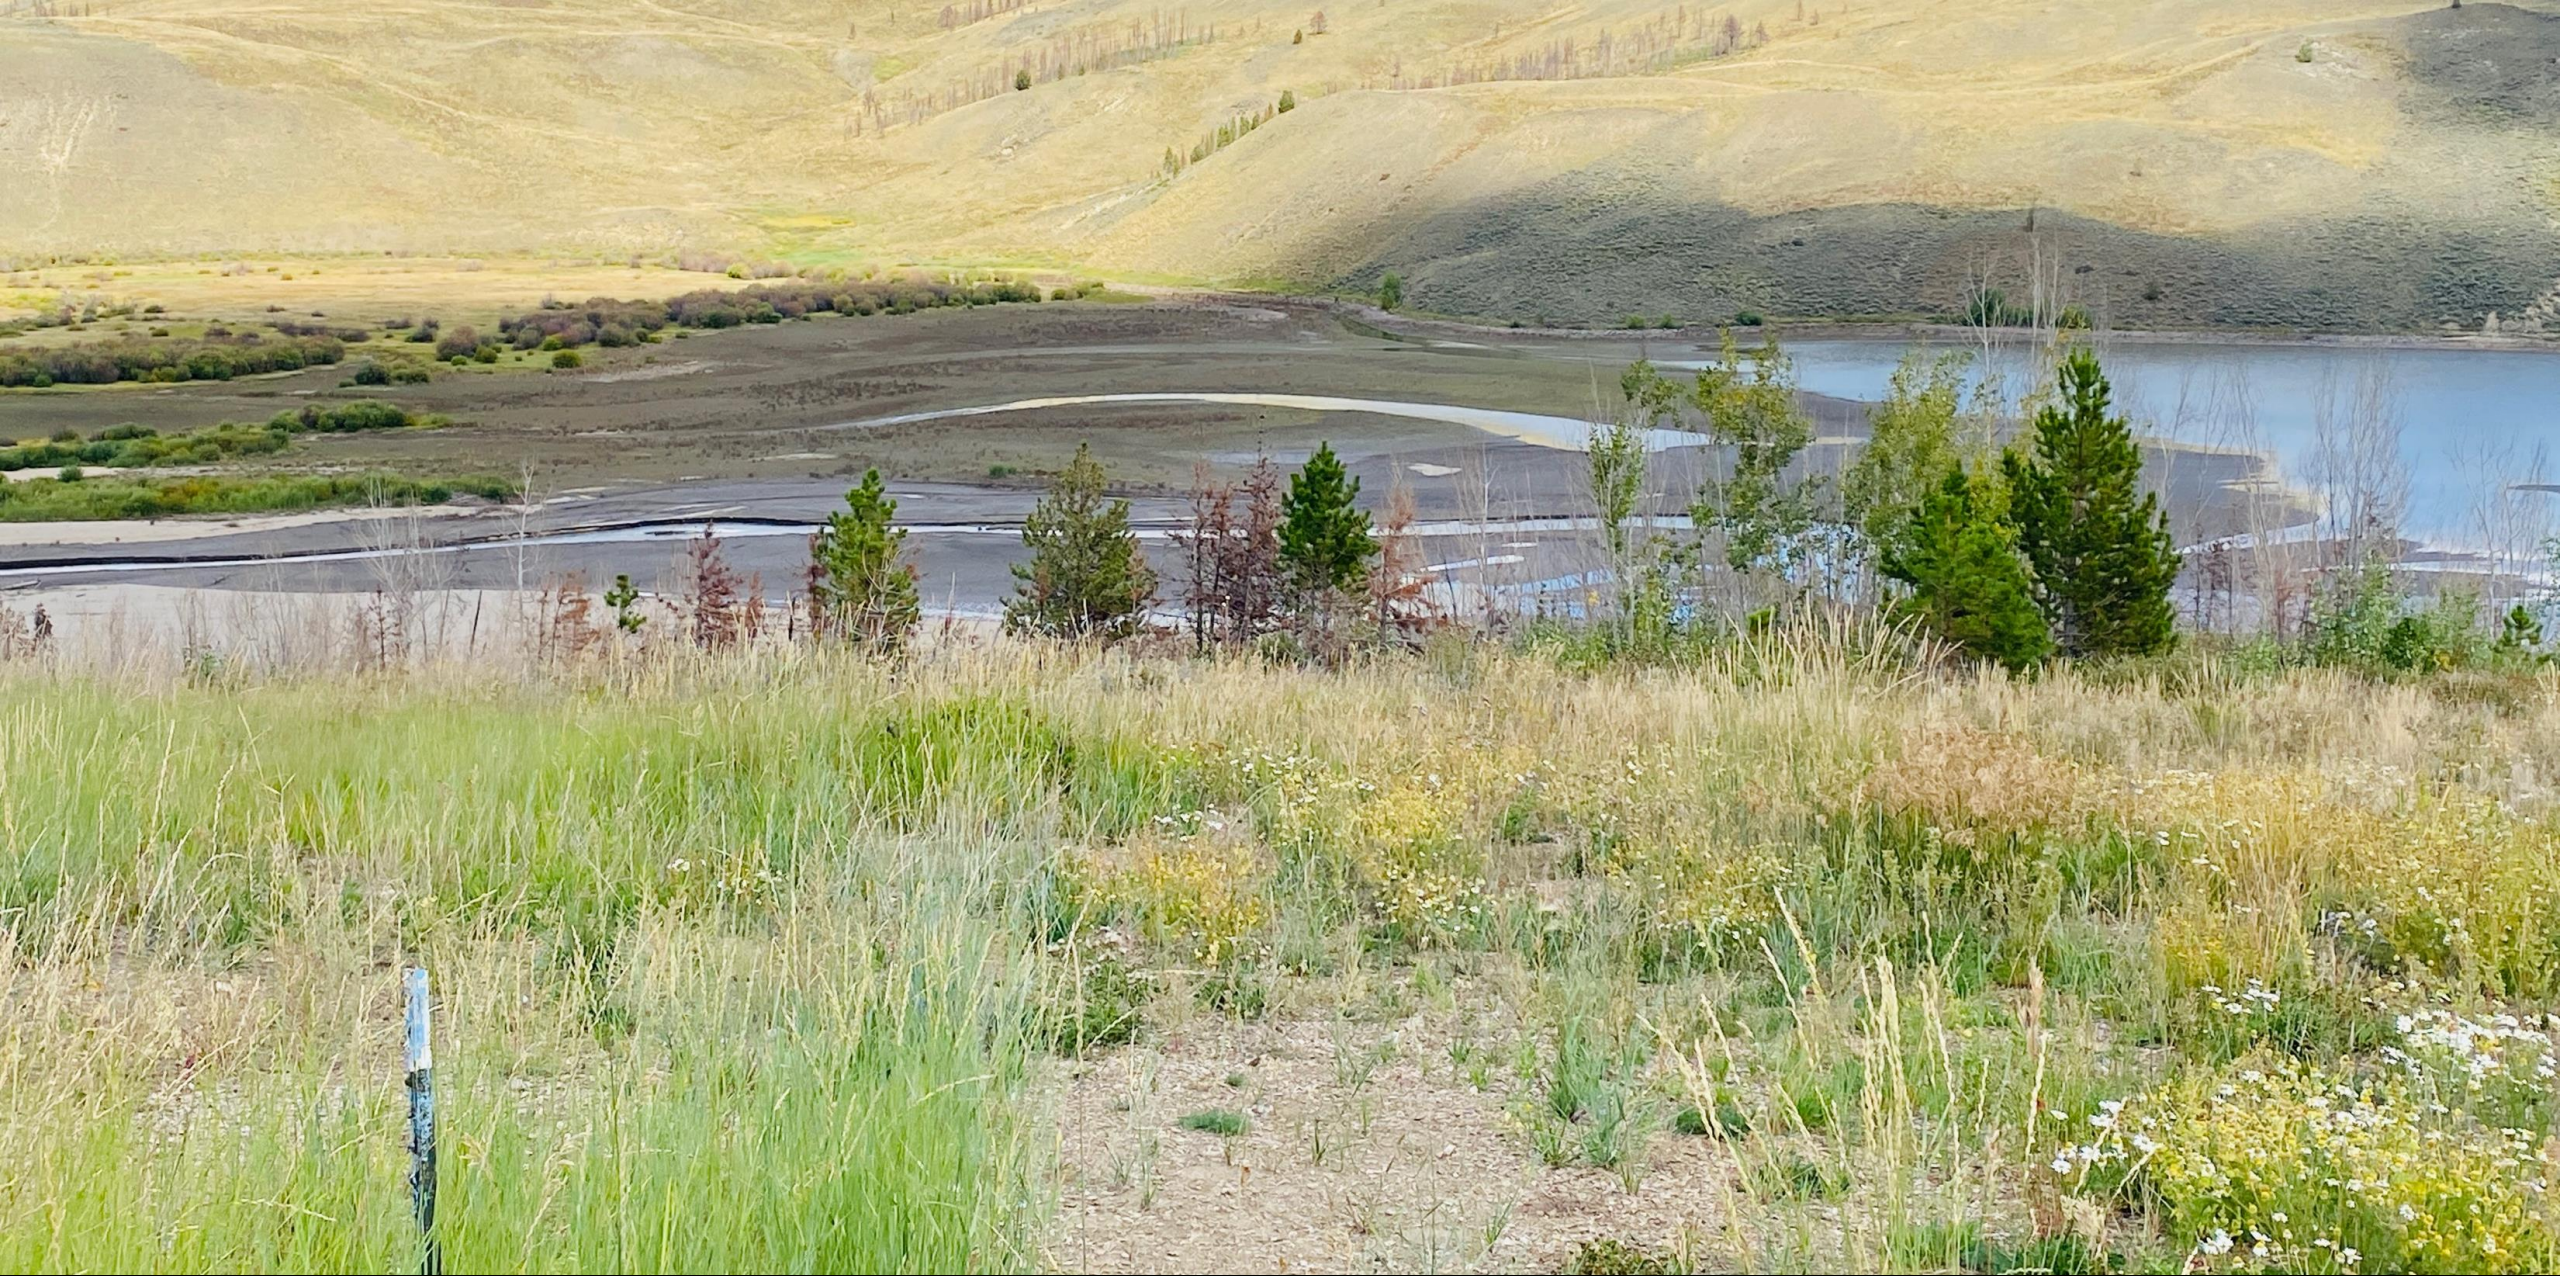
WILLOW CREEK RESERVOIR DELTA – SEPTEMBER 2022
